MSRE Operation Highlights

Molten Salt Reactor Workshop 2017
Oak Ridge National Laboratory

MSRE Operated Remarkably Successfully for a First of a Kind Reactor

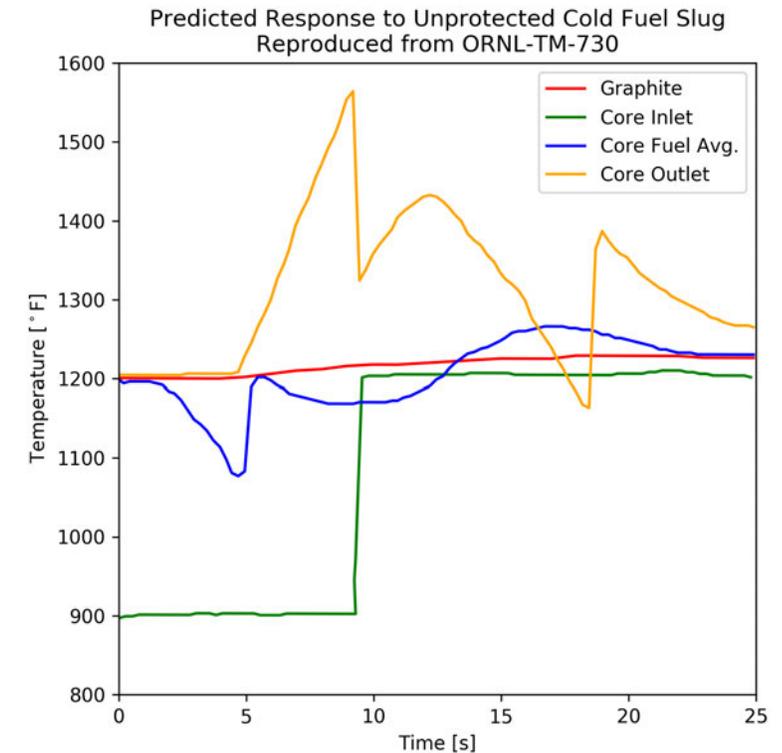
Temperature prediction for
unprotected cold slug accident

- MURGATROYD code logic was developed and validated for Aqueous Homogeneous Reactor design
 - Extended to provide separate graphite heat capacity
 - Single point, single energy group, seven delayed neutron precursor groups
 - Employed for both design and safety calculations
 - Beta effective based upon the fraction of the time fuel in the core
- ZORCH code developed that includes axial spatial dependence in fuel and graphite temperature to more accurately represent transient responses
 - Shows that no damage would be anticipated even for unrealistic transients
 - Maximum fuel temperature anticipated ~ 850 °C (< 5 seconds) for unprotected cold slug addition
- Equipoise 3A code performed 2D, two group diffusion calculations for steady state power distribution and reactivity coefficients

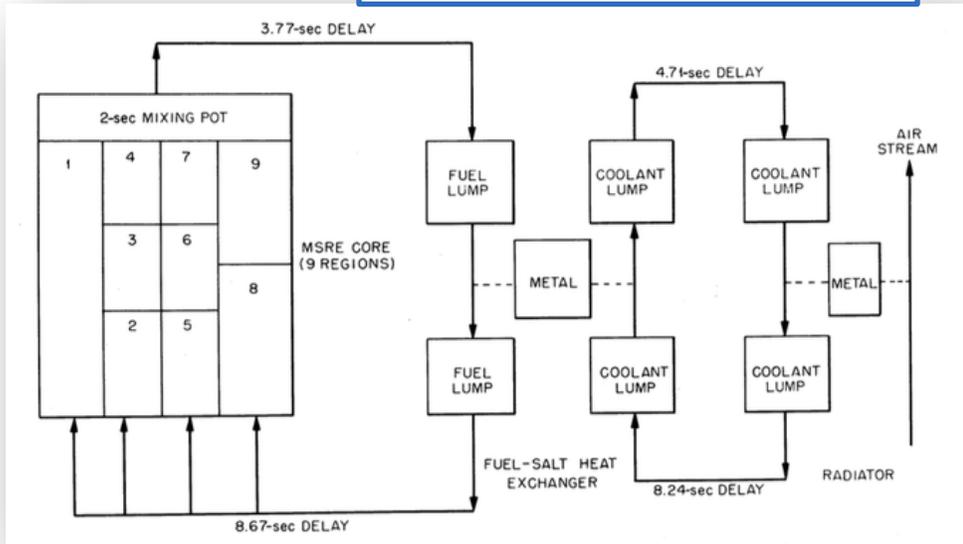
MSRE Reference Model

- Dynamic plant model predicted stable operation – which was confirmed using low power testing
 - 44th - order system matrix with 4 time delays for heat convection and 6 time delays for precursor circulation
 - Solved with MATEXP Code
- Main conclusion – system has no operational stability problems and its dynamic characteristics were as predicted

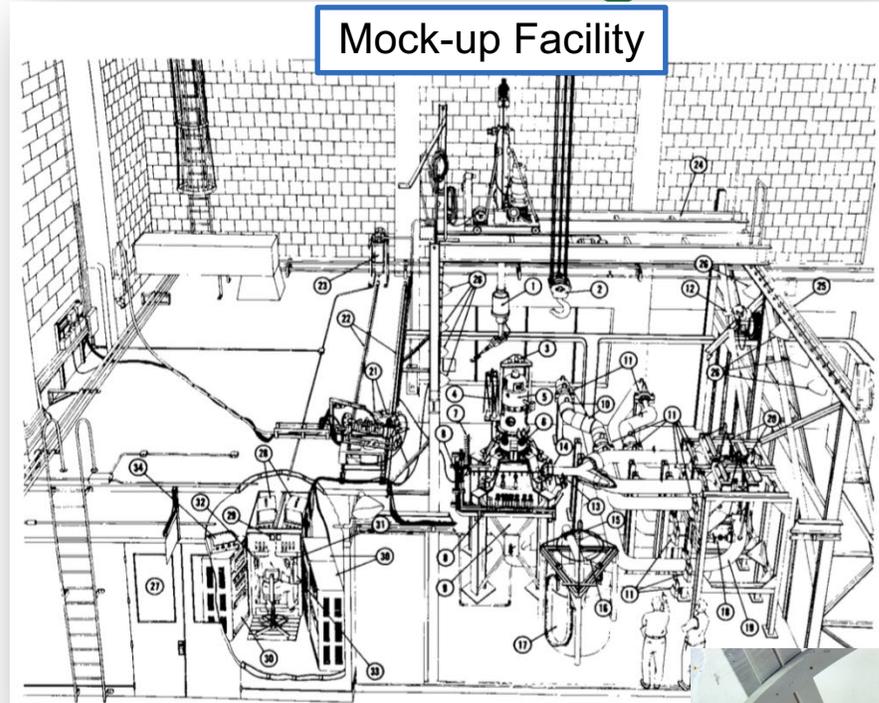
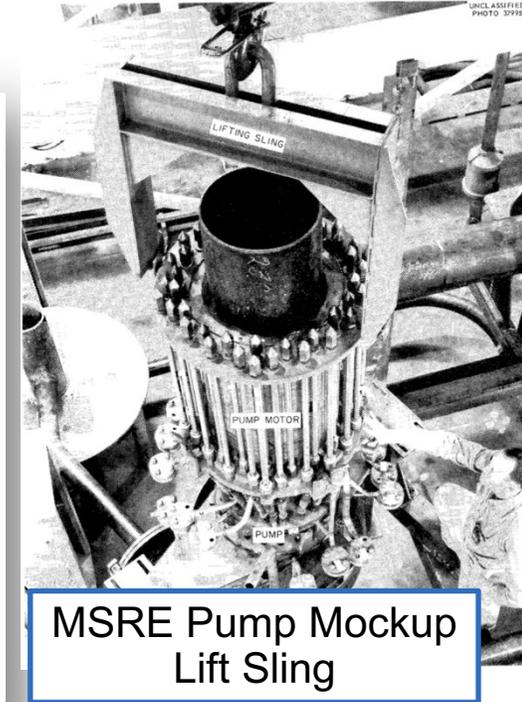
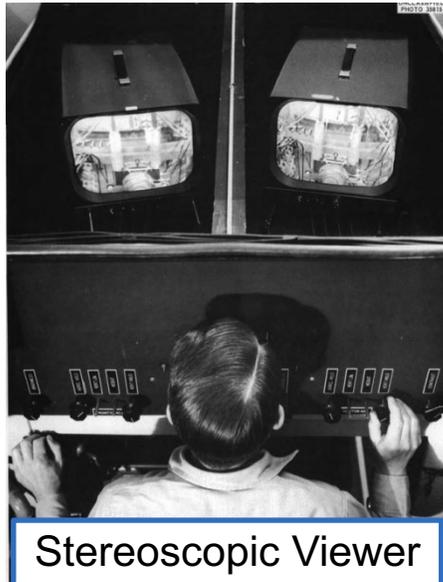
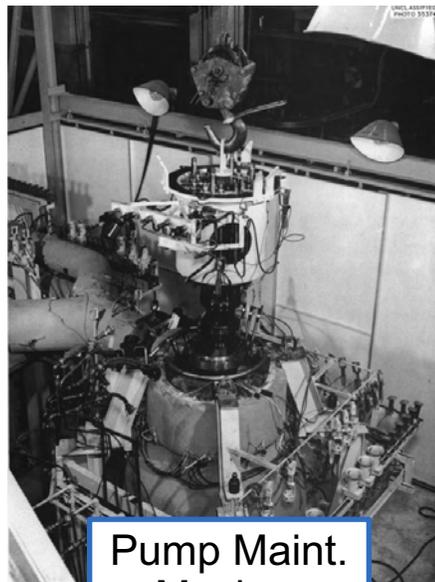
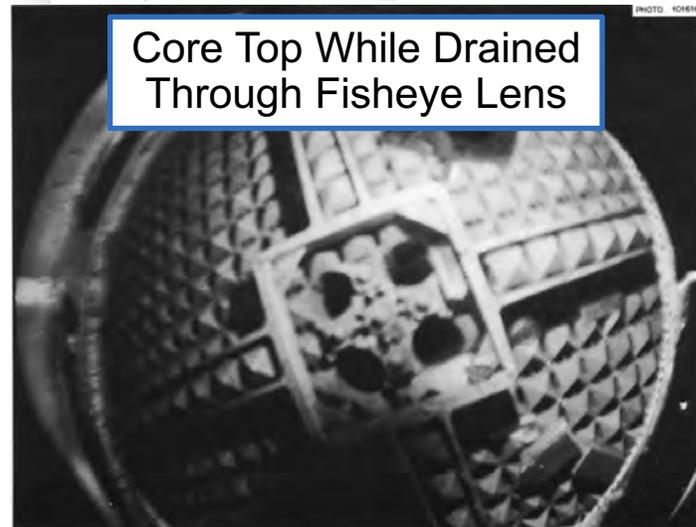
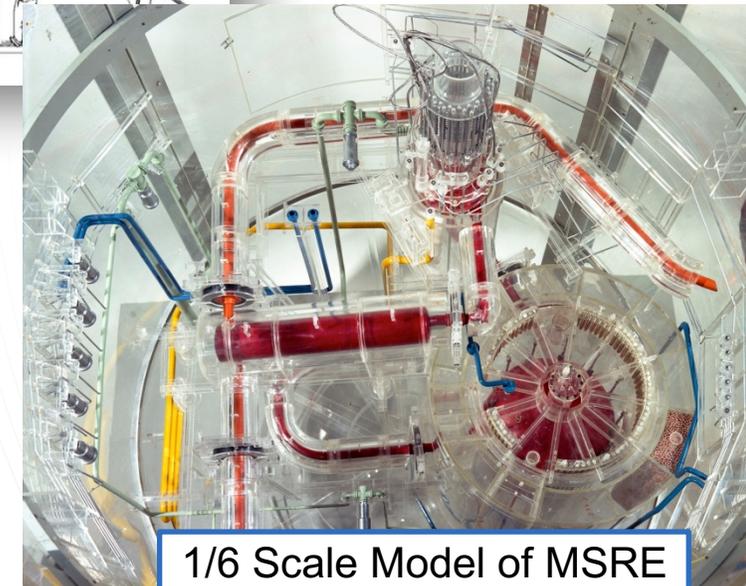
- Remote maintenance mock-up facility created
 - 650°C mock-up of 20 MWt MSR
 - Tools, techniques, and procedures for replacing all major components including heat exchangers, fuel pumps, reactor core vessel, pipe preheaters, and piping sections developed and demonstrated

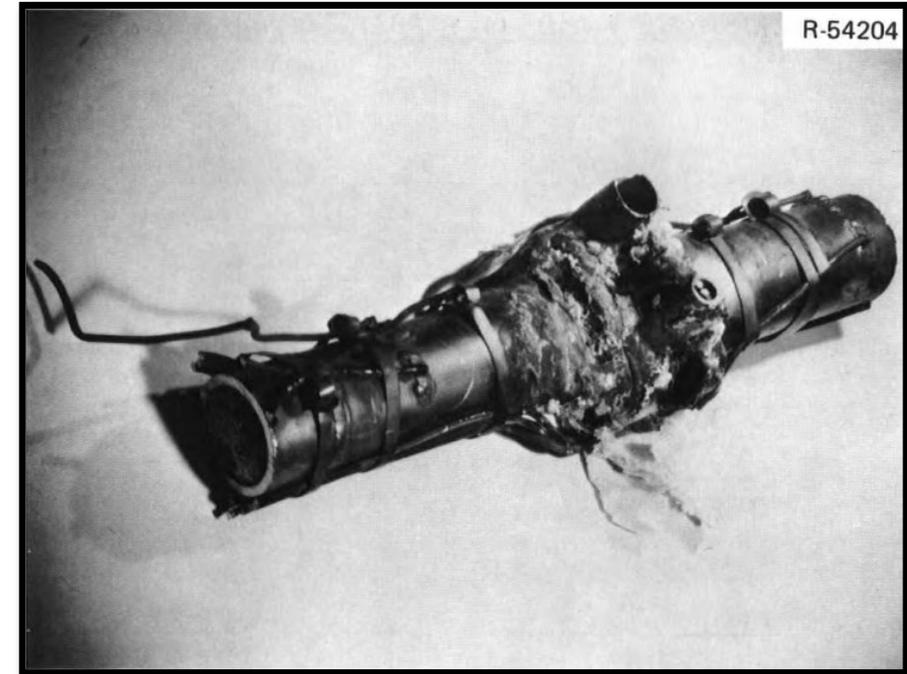
Bottom of cracked freeze valve

- Reactor vessel progressively embrittled due to neutron damage
 - Thick reflector recommended
- Drain tank isolation freeze valve cracked during its final cycle due to a field modification
 - Stiffening the air-cooling housing prevented pipe flexing
 - Xenon, iodine, krypton, and noble metals detected in reactor cell
- Pump-entrained gas caused sporadic (about 10 times/h) increases in reactor power ($\sim 5\text{--}10\%$) for a few seconds
 - Addressed by changing pump frequency
- Fuel-salt contacting materials
- Small, continuous leak of lubricating oil into fuel pump caused issues
- Control rod failed scram test due to snagging on thimble

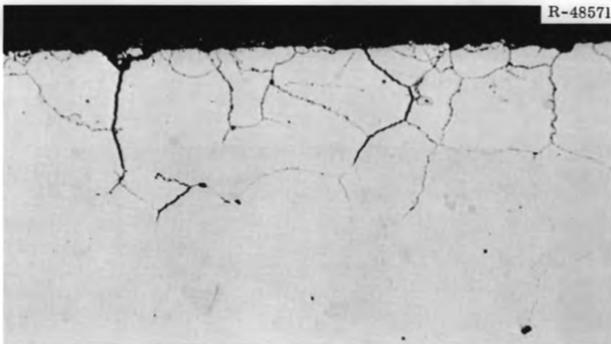
Typical microstructure of Alloy N after exposure to MSRE core for 22,533 h at 650°C – 500x

- Would be unacceptable for multi-decade lifetimes for thin-walled components
- Tensile testing of Alloy N surveillance specimens from the MSRE produced cracks in the grain boundaries connecting to the salt-exposed surfaces containing tellurium
- Intergranular embrittlement can be reduced by adding 1–2% niobium to Alloy N or by maintaining the salt in reducing conditions

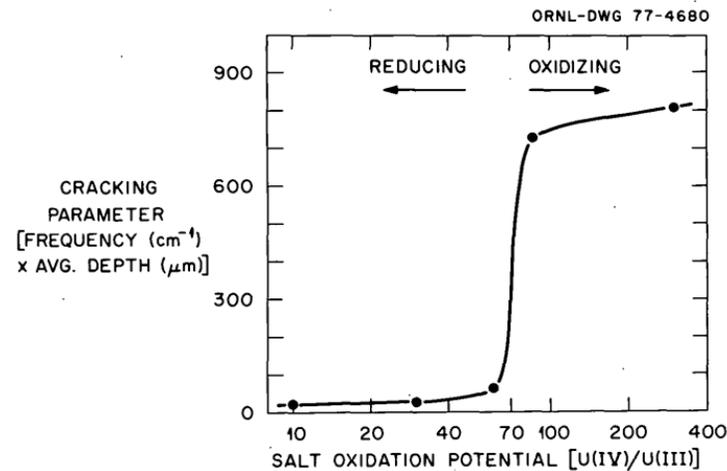
Reducing condition improves performance

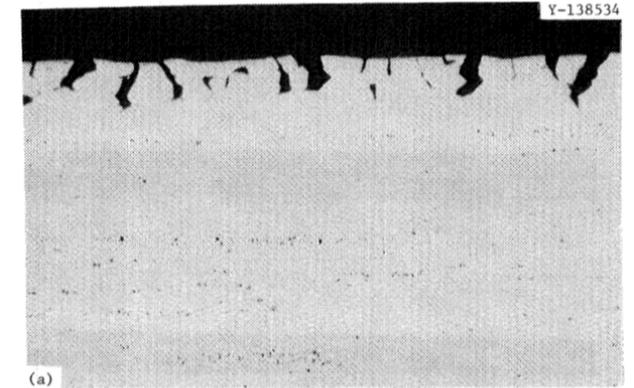
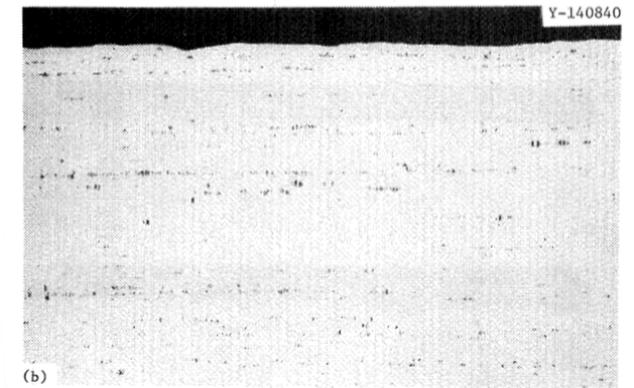
Alloy N exposed to MSRE fuel salt (500 h, 700°C) containing tellurium (a) oxidizing, (b) reducing – 100x

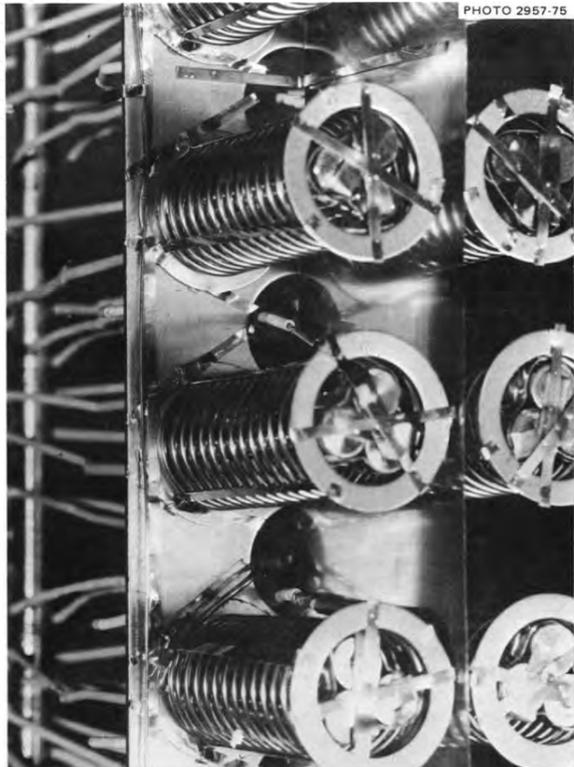
Cluster of modified Alloy N creep specimens prior to irradiation

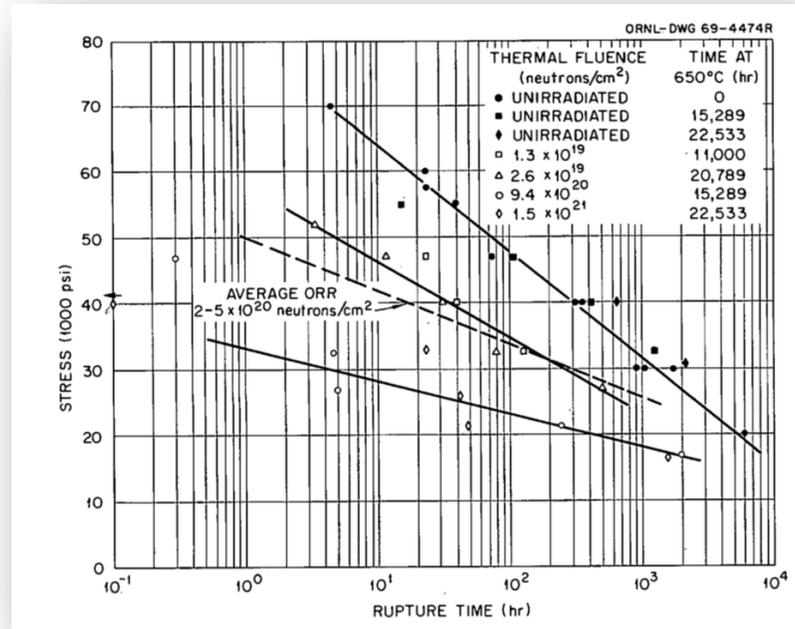
Stress rupture properties of MSRE surveillance specimens

All niobium-modified Alloy N specimens irradiated at 650°C had rupture lives in excess of those of standard unirradiated Alloy N

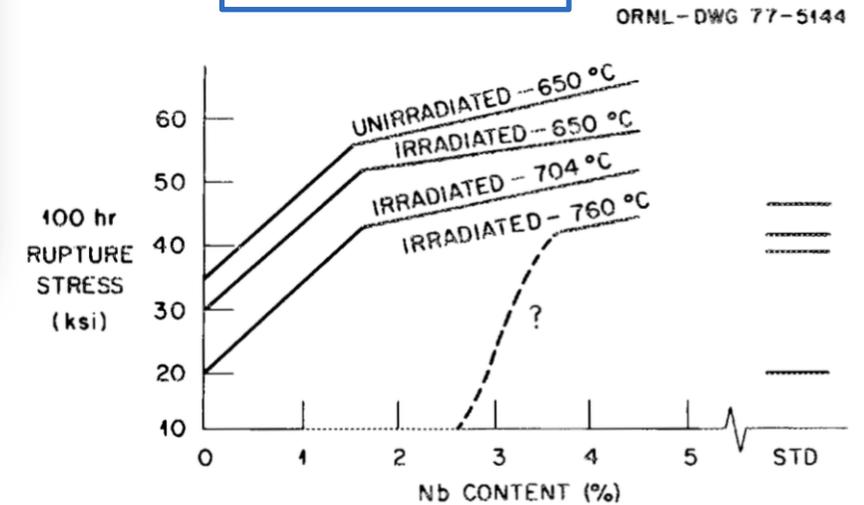
Influence of Nb on stress rupture properties

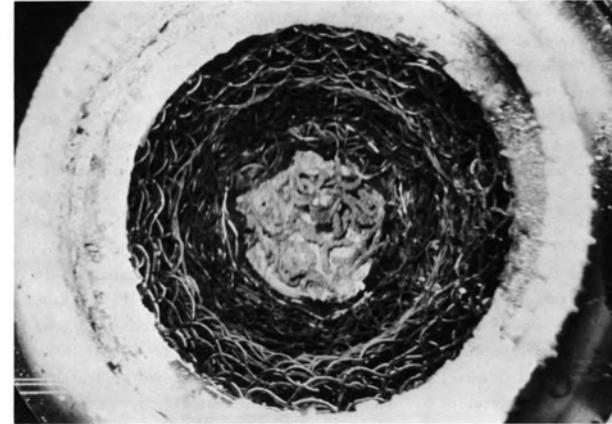
WG 67-4764

MSRE Mark 1 Offgas Particle Trap

- Lubricating oil leaking from pump seal caused issues with filters, check valves, and control valves
- Hydrocarbons tended to have gaseous fission products stick to them and in turn deposit on the particle filters thus clogging the system
- Problem was substantially reduced by employing a larger (15 versus 10 cm diameter), redesigned particle trap
- Key recommendation: **Avoid use of hydrocarbon lubrication in all salt-connected systems**

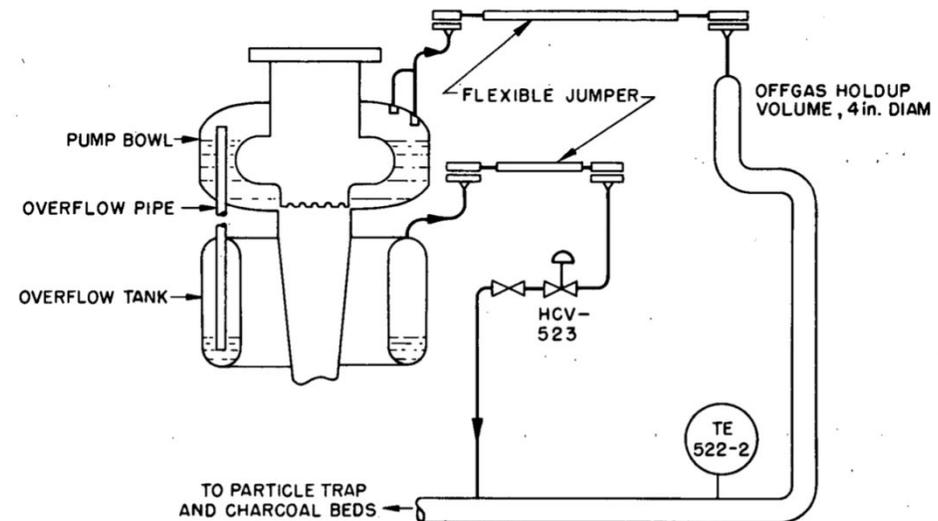
Offgas Piping Near Pump and Overflow Tank

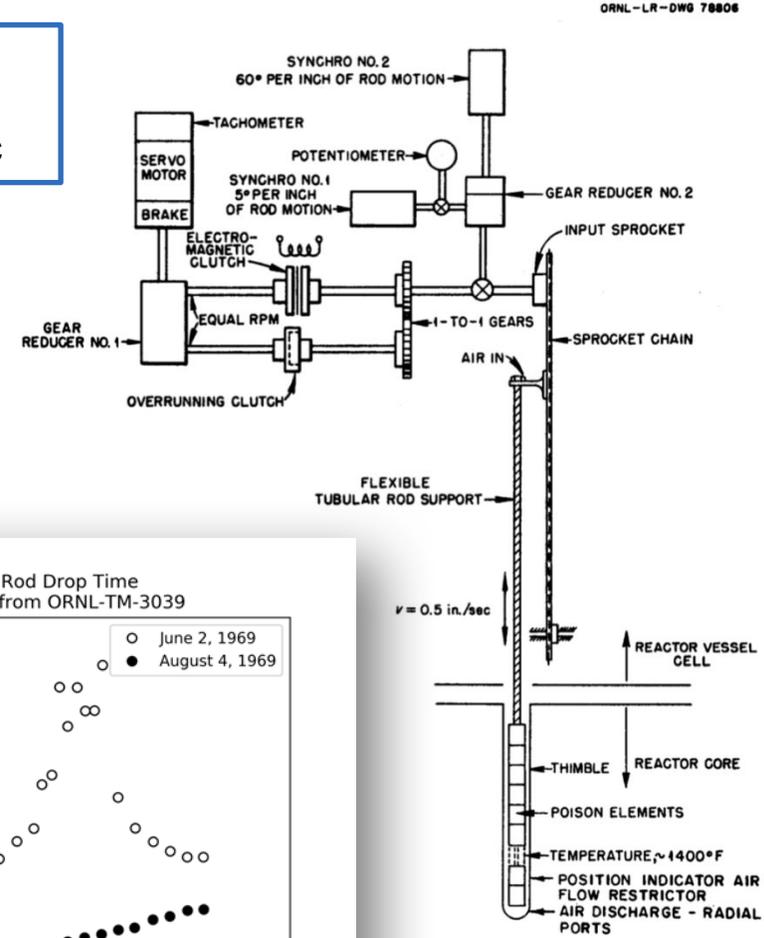
Absorber control schematic

- Over 3000 scram tests performed with only one failure
 - Rod 3 stuck at 35 inches in channel
- Experimental ‘rod-jogger’ stuck control rod in out position during a *pseudo random binary sequence* test
 - Power level ramped up then decreased without intervention
- Mechanical wear was resulting in progressively longer drop times
 - Rods were used to shift power levels, to compensate for fission product buildup, and for fueled shutdown

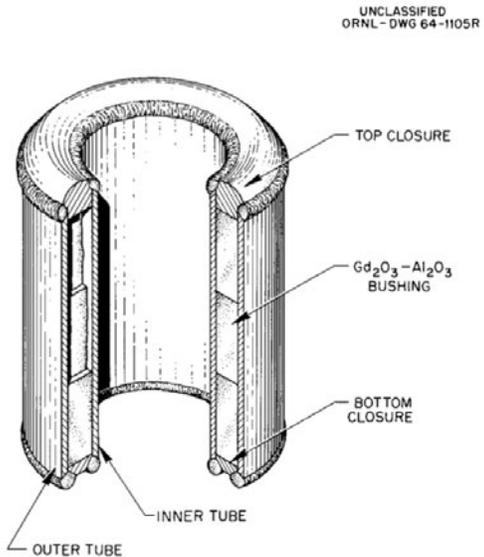
Absorber element section

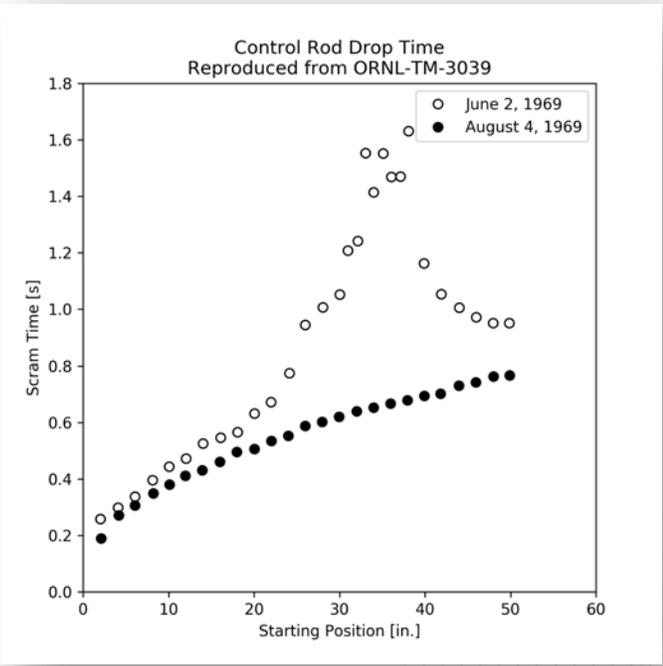
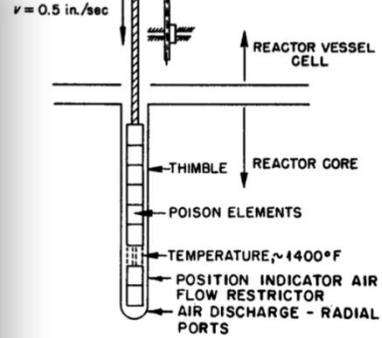
Stuck element and normal drop
