Irradiated Material Advanced Repair Welding

Molten Salt Reactor Workshop 2018
October 3, 2018

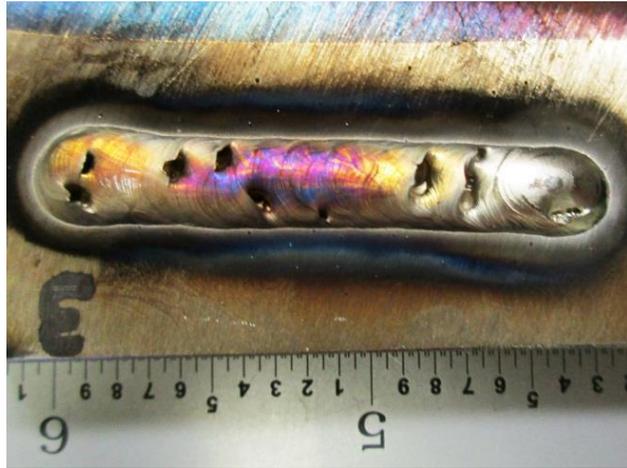
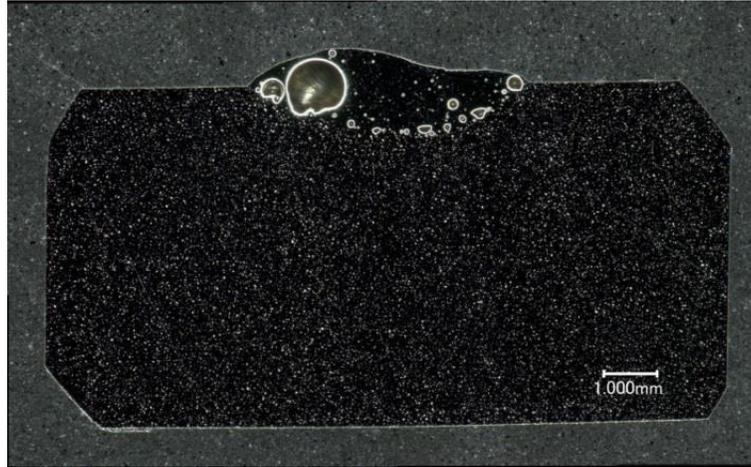
Huge voids and cracks with fusion welding

- Recent work performed on high helium content stainless steel produced by powder metallurgy
- Friction stir welding (FSW) suppressed voids and cracks due to its solid state low welding temperature.

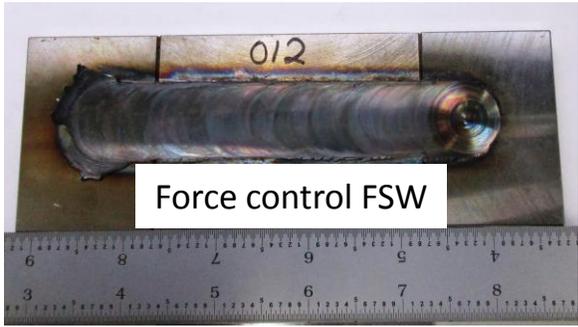
- A. Welding Table
- B. Clamping Vise
- C. Coupon
- D. FSW Head
- E. Extensometer

- Initial parameter development performed using **force control** friction stir welding, whereas the hot cell will rely on **position control**
- Machine deflection was identified as a contributor to surface defect formation during initial friction stir welding trials inside hot cell on unirradiated materials
- Software updated to incorporate z-axis position control (preprogrammed or manual)

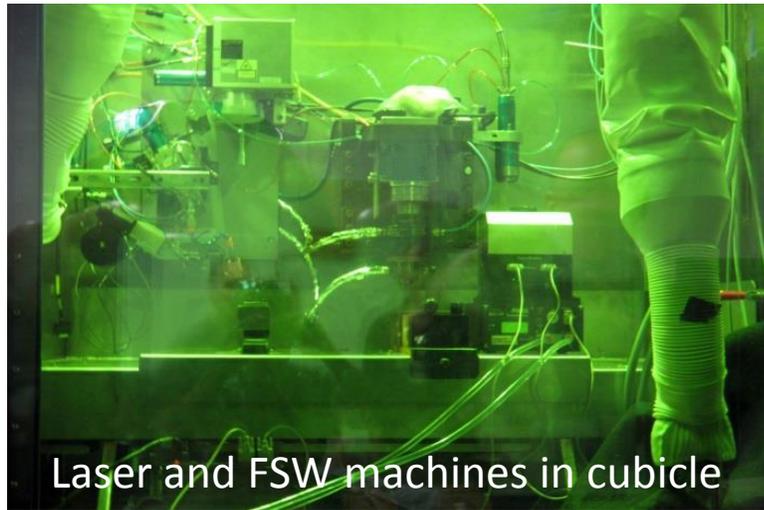
Laser and FSW machines in cubicle

- Welding cubicle is installed at the Radiochemical Engineering Development Center (REDC), Cell 6.
- Manipulators are used for material transportation and welding preparation
- Cameras are installed in and outside of the cubicle for monitoring
- Material surface preparation at Irradiated Materials Examination and Testing (IMET)

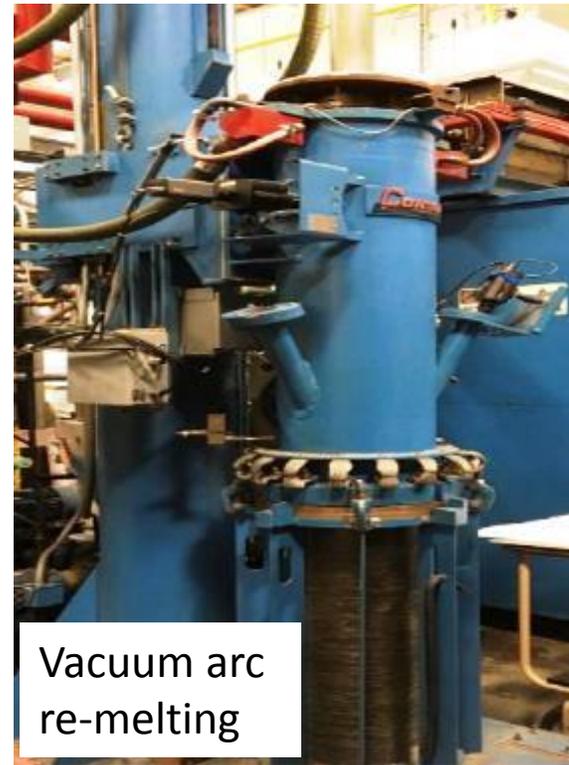
- Custom made 304L, 316L, and 182 alloys
- Targeted boron concentrations of 0, 1, 5, 10, 20 and 30 wppm B.
- Low Co impurity levels.
- Processing:
 - Vacuum arc re-melting (VAR) stock material
 - Hot extrusion at 1100 °C
 - Homogenized at 1100°C for 5 hours in air
 - Hot rolled to 19 mm thick, followed with cold rolling to 12 mm thick.
 - Solution heat treatment (1000°C for 30 minutes for 304L and 1050°C for 30 minutes for 316L followed by water quenching)
 - Machined to: 76 x 56 x 8.9 mm coupons
- PNNL and ORNL modeling to estimate helium concentrations based on alloy composition and neutron spectra
- Thermal desorption spectrometry (TDS) and laser ablation mass spectroscopy (LAMS) at ORNL to determine level of helium after irradiation.

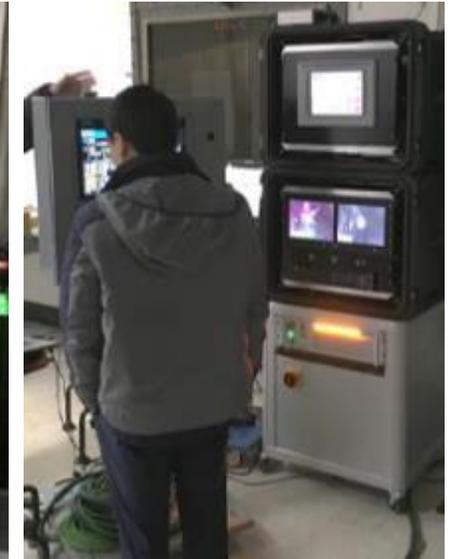
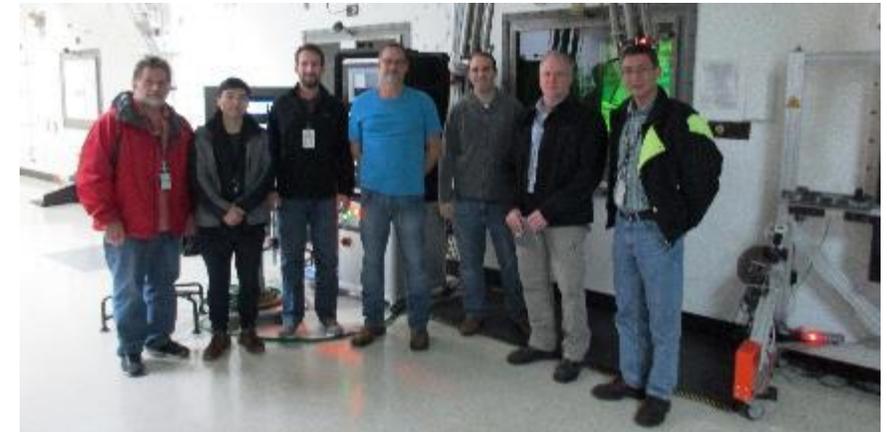
- Developing advanced weld technologies capable of addressing challenges associated with highly irradiated materials
- The LWRS Materials Research Pathway Welding team at ORNL partnered with the Electric Power Research Institute to begin weld testing on irradiated materials at the Radiochemical Engineering Development Center at ORNL
- Auxiliary beam stress improved (ABSI) laser welding on irradiated 304L stainless

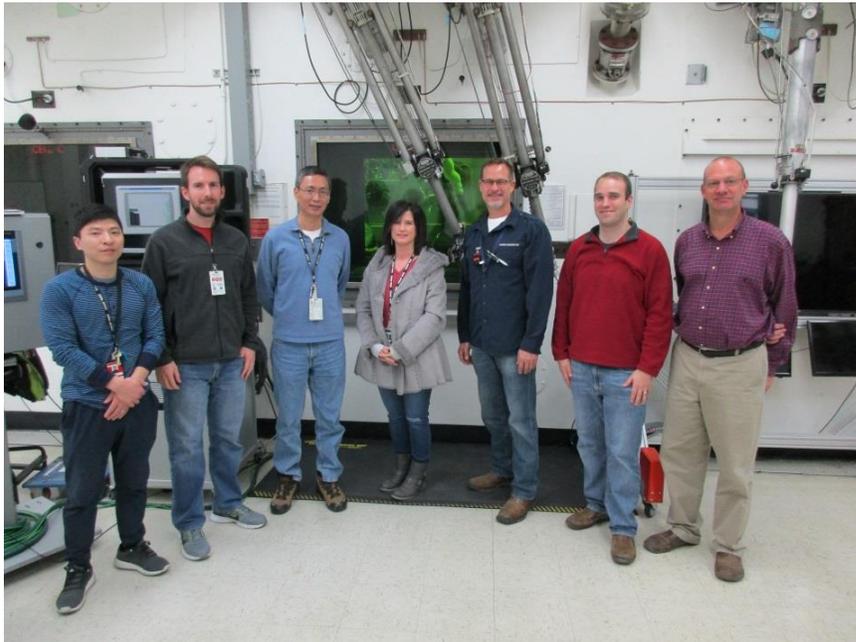
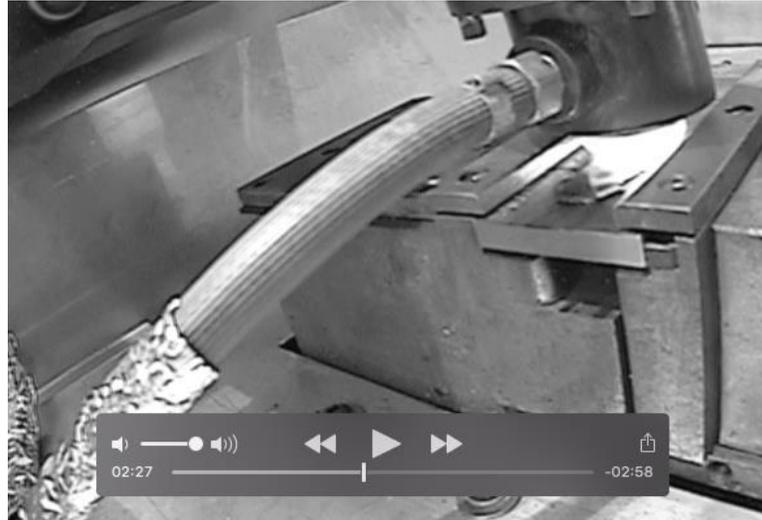
- Developing advanced weld technologies capable of addressing challenges associated with highly irradiated materials
- Weld repair technologies are needed as a critical technology for extending the service life of nuclear power plants
- The LWRS Materials Research Pathway Welding Team at ORNL partnered with the Electric Power Research Institute to begin friction stir weld tests on irradiated materials with 10 wppm B and 5 wppm B prior to irradiation (26 appm and 8.48 appm measured He) at the Radiochemical Engineering Development Center

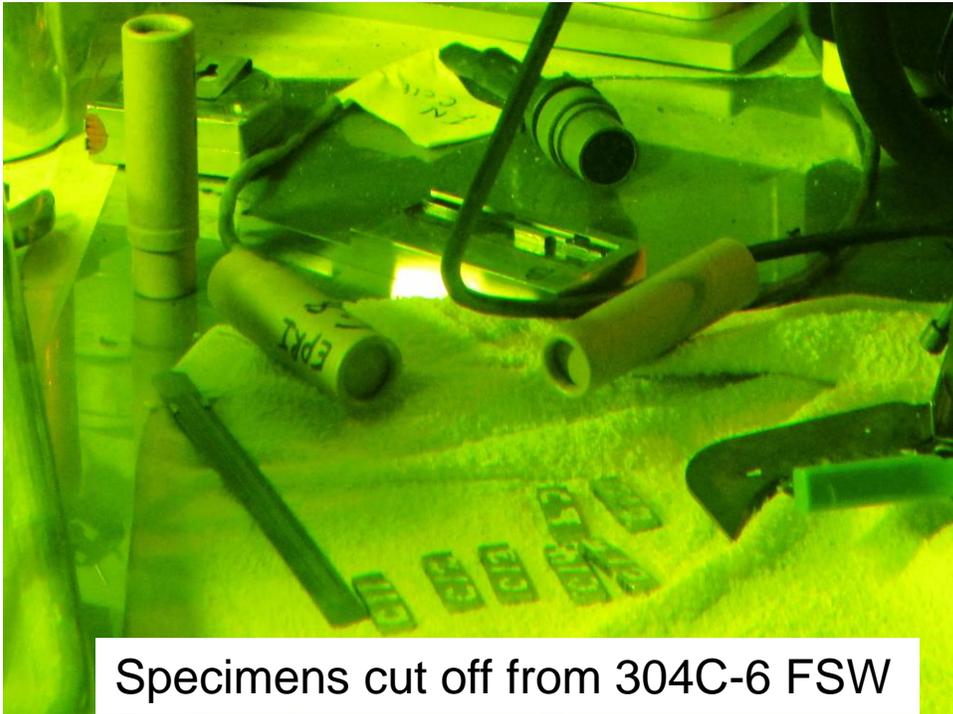
Specimens cut off from 304C-6 FSW

Specimens cut off from 304D-1 LBW

- For each irradiated material welded coupon, cut off specimens were marked with a paint maker, laid out on a towel inside the hot cell, and placed into corresponding fiber tubes after all specimens were cut off from the welded coupon.
- Remaining parts of irradiated material welded coupons were placed into corresponding aluminum containers for long term storage at IMET.
- Cut off specimens will be sent to Low Activation Materials Development and Analysis (LAMDA) for microstructure characterization, helium measurement, microhardness mapping, mini-tensile specimen machining, and tensile testing.

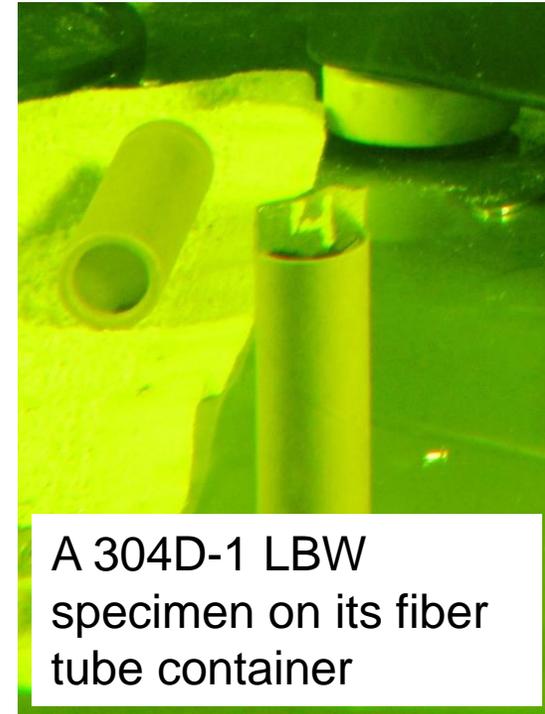
A 304D-1 LBW specimen on its fiber tube container

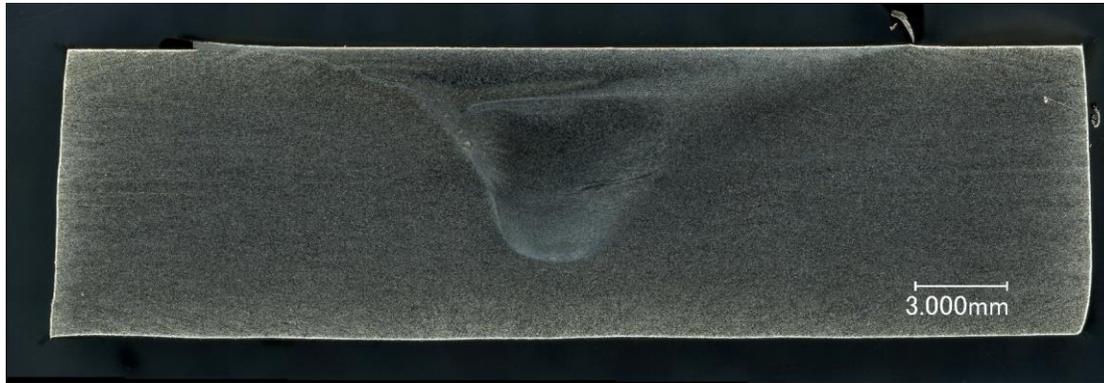
Un-irradiated 304L friction stir weld cross section

Irradiated 304L friction stir weld cross section

- Due to the high plastic deformation in FSW, high shear zones are observed with both un-irradiated material and irradiated material FSW.
- At high shear zone interfaces of irradiated material FSW joint, such as weld boundary, lots of black spots, which sizes are mostly in nanometer scale and a couple of micrometer scale, were observed. They could be voids or inclusions. Further study is needed to identify them.
